LINE OF DUTY DEATH REPORT

REPORT F2024-02 • March 2025

Career Engine Company Officer Dies in Abandoned, Single-Family Structure Fire – North Carolina

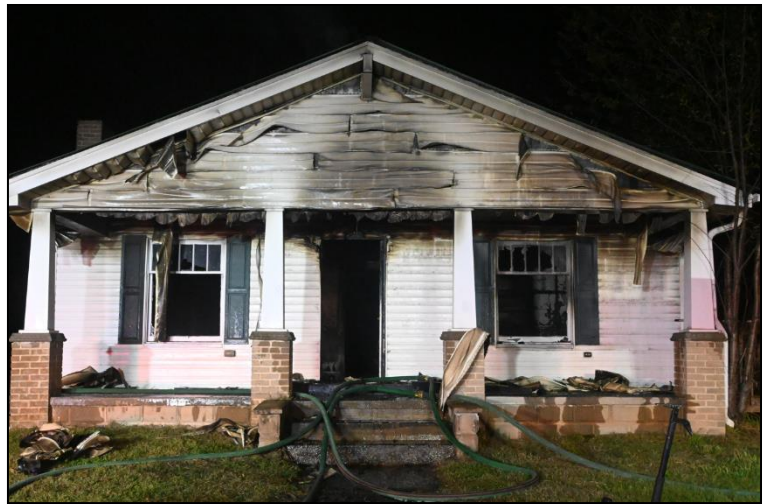
Side Alpha post fire event
(Courtesy of Fire Marshal Office)

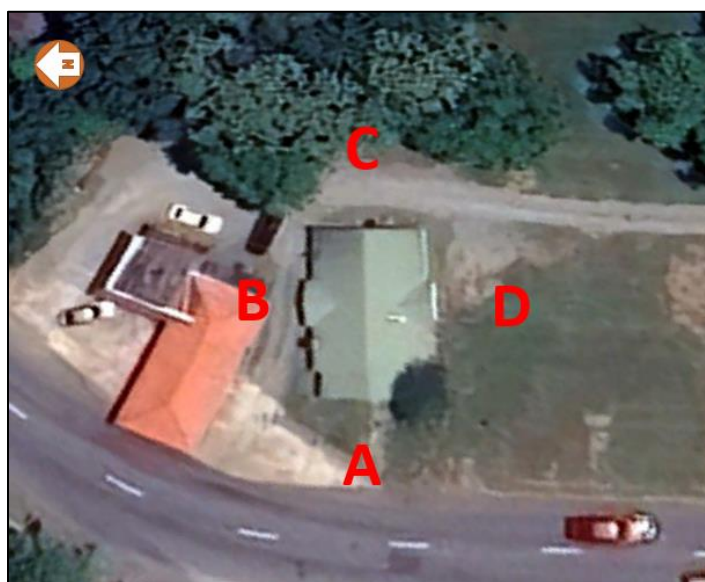
Photo: 1 Aerial view of structure with sides of the structure labeled A (Alpha), B (Bravo), C (Charlie), and D (Delta)
(Courtesy of Google Earth)

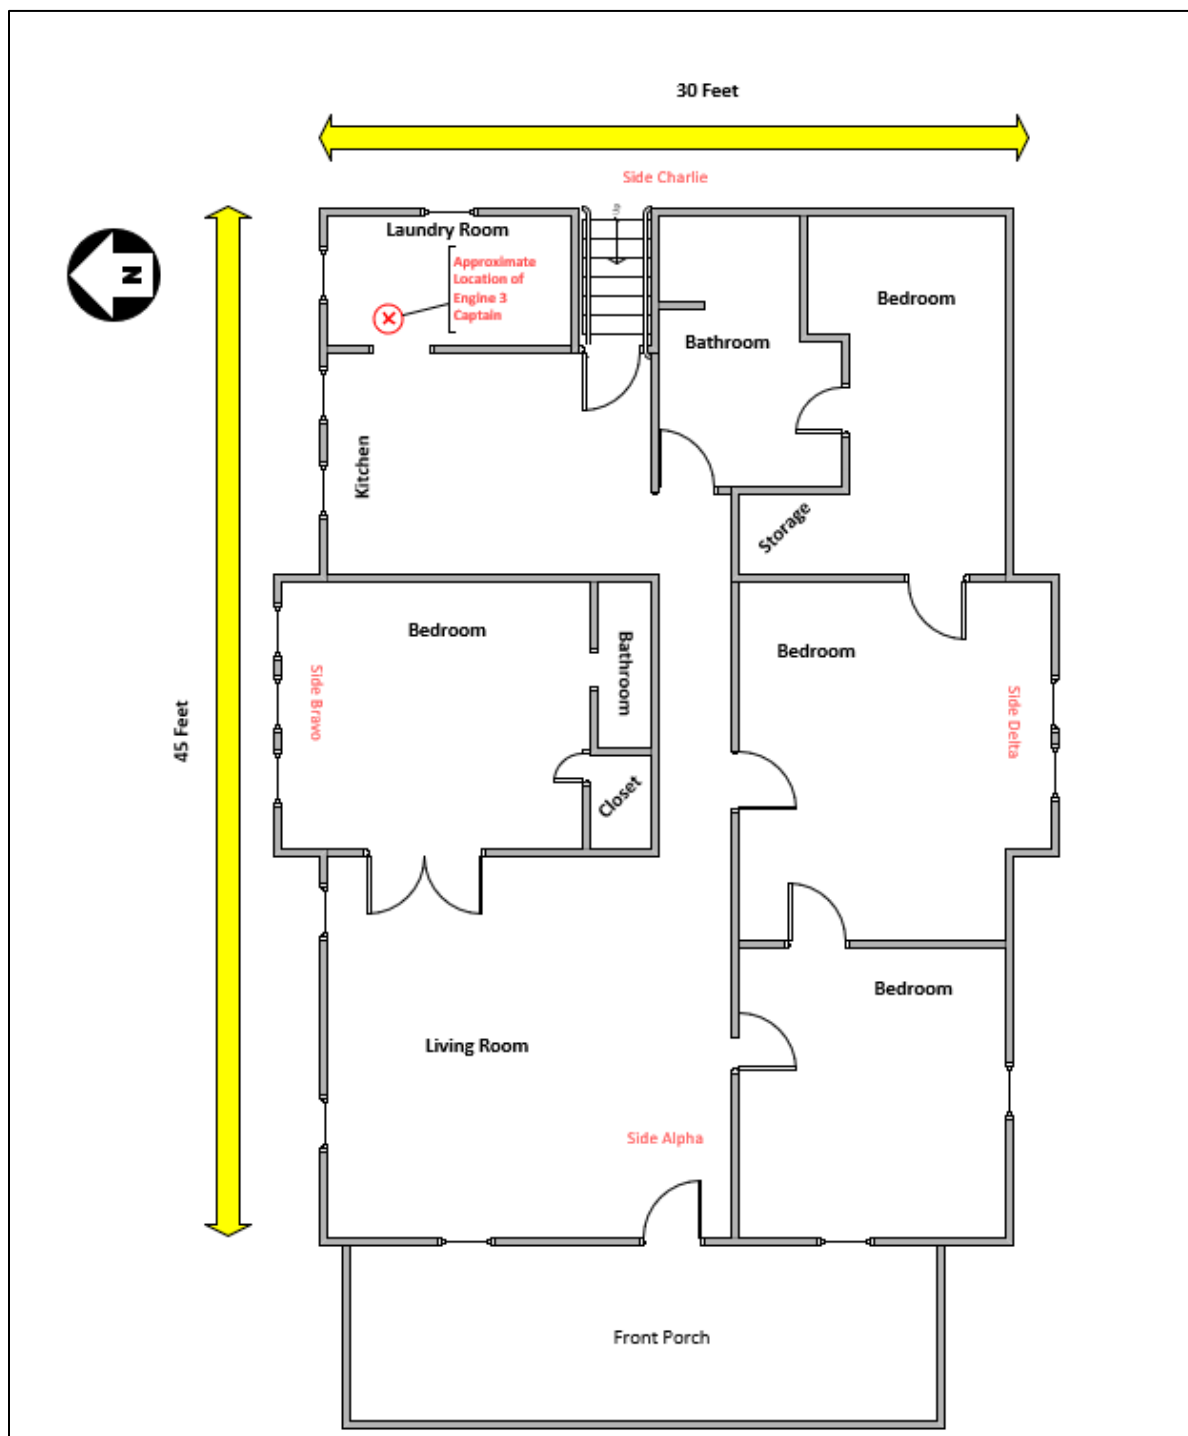
Diagram 2: First floor diagram and approximate location E3 captain was found.

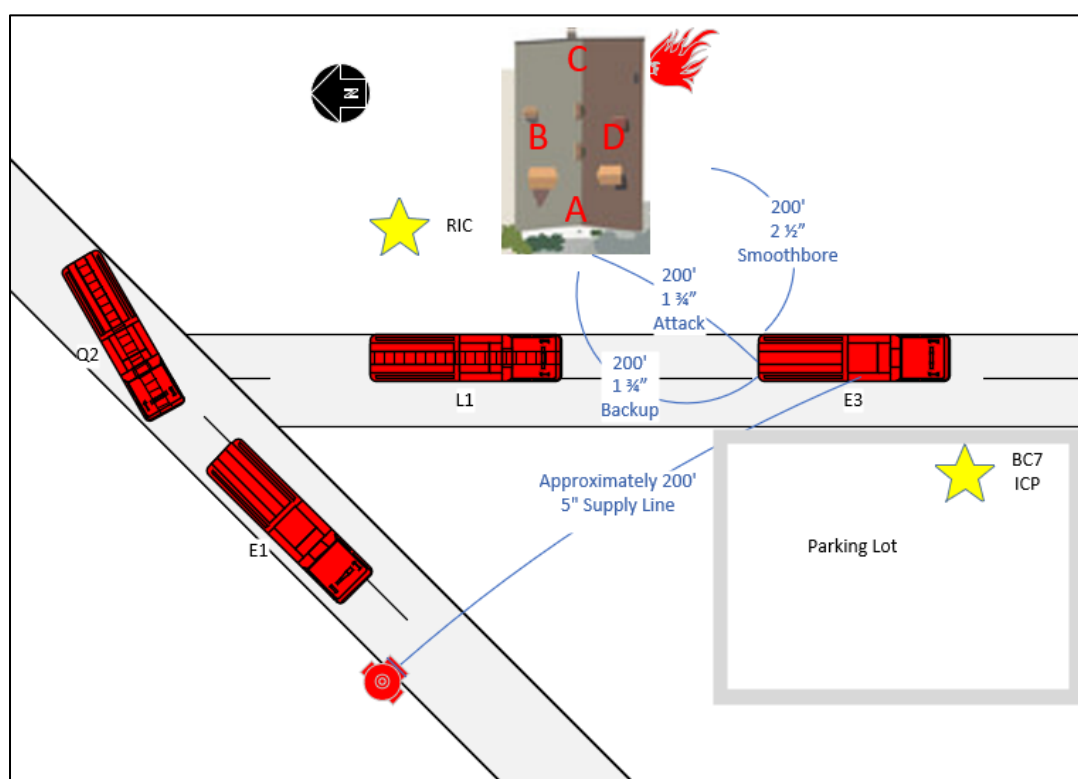
Diagram 3: Apparatus, attack, supply line placement.
