LINE OF DUTY DEATH REPORT

REPORT F2024-02 • March 2025

Career Engine Company Officer Dies in Abandoned, Single-Family Structure Fire – North Carolina

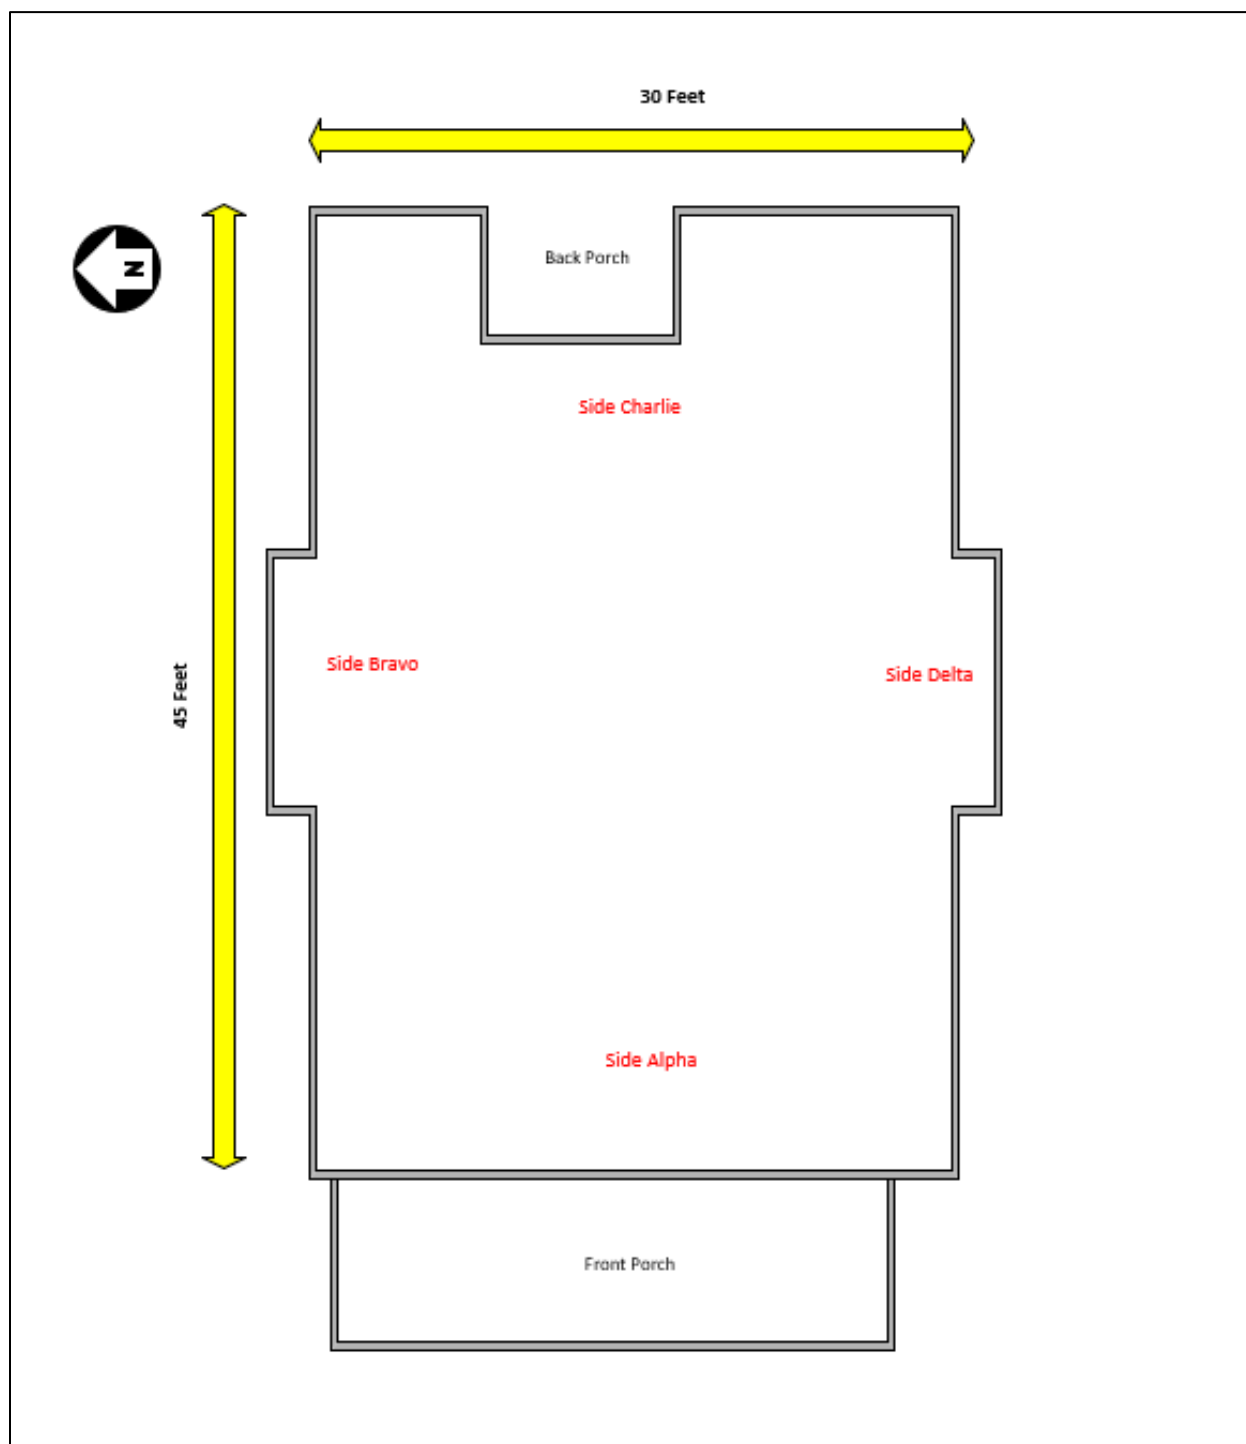
Diagram 1: Structure diagram
(Courtesy of NIOSH)

This structure had four-bedrooms and two-bathrooms. It was built in 1930 and was wood frame construction with a vinyl siding exterior. It contained 2x4 interior stud walls that were covered with both common drywall as well as lath and plaster interior finishings. The sloping roof structure was constructed of wood roof rafters covered in a metal roof exterior finishing. For this report, side Bravo is orientated to the north followed by side Charlie to the east, side Delta to the south, and side Alpha to the west (see **Photo 1**). NIOSH investigators were able to gain access to the structure to take photographs and measurements.
