# LINE OF DUTY DEATH REPORT

REPORT 2019-01 • January 2025

## ***Industrial Silo Fire and Subsequent Explosion Kills One Firefighter and Critically Injures Another - Iowa***

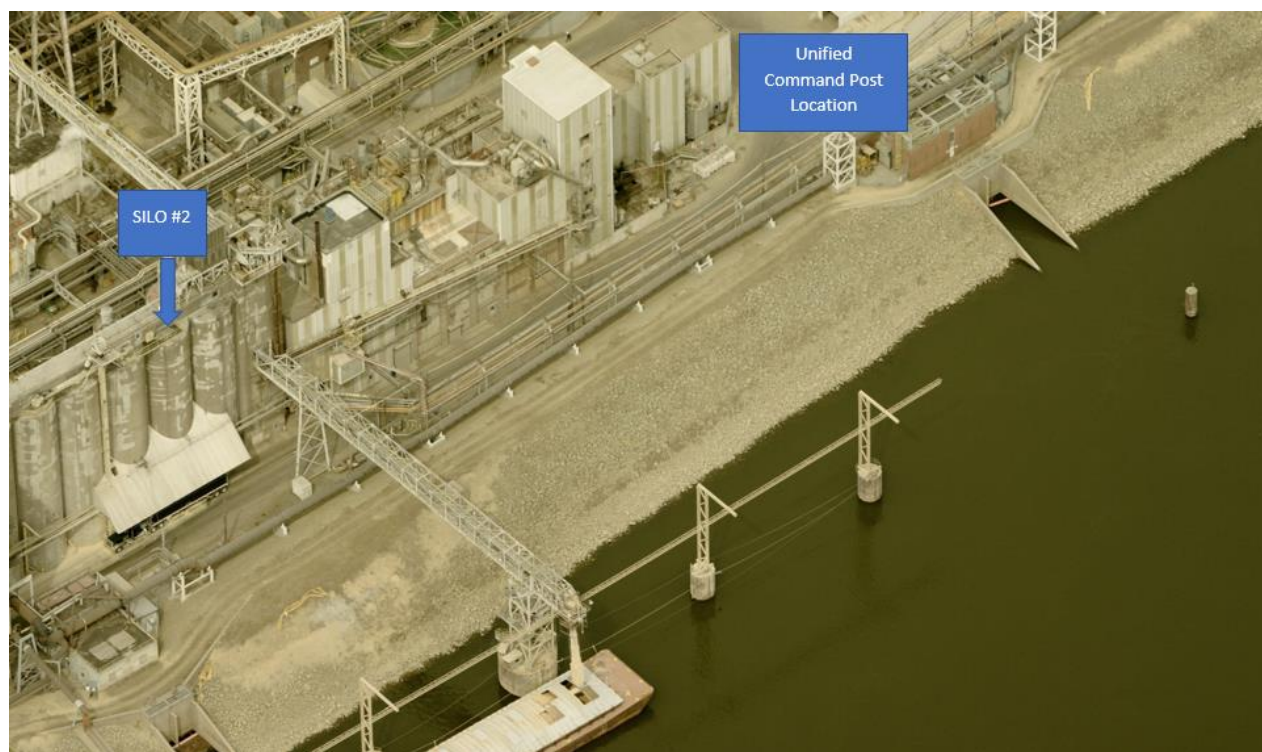
**Photo 2. Location of silo #2 in relation to command post.**  
*(Courtesy of the fire department)*

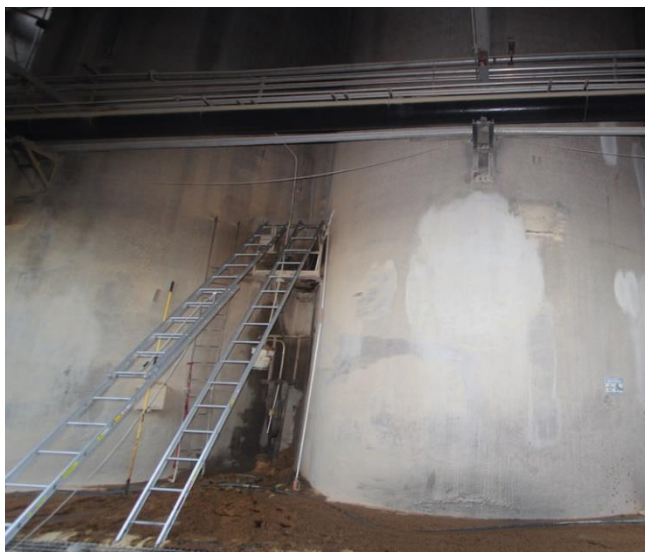
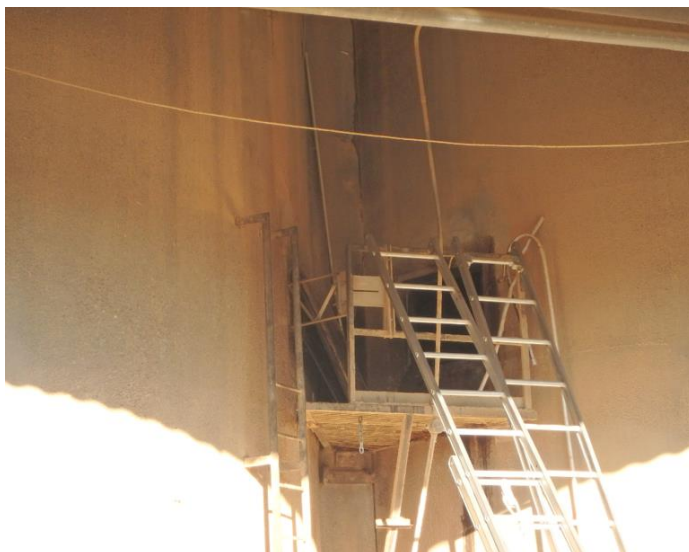
**Photo 3 and 4. Location and ladder configuration used to locate and rescue CO3 firefighter from inside silo #2.**  
*(Courtesy of the fire department)*

A member of the contractor crew then updated B2 about the side access hatch on the silo that could be used to aid the search (**See Photo 3 and 4**). Upon opening the hatch, they observed the semi-conscious CO3 firefighter sitting on the silage against the inside silo wall. They did not observe any fire in the silo. A second ambulance and helicopter were requested by Command at 09:27 hours. Command noted to the PSAP that they had a fall victim who was talking and that ongoing efforts were underway for extracting the victim from inside the silo. Firefighters began unbolting the side access hatch to gain a larger opening. CO3 firefighter then crawled to the opening and was secured in a stokes basket which was lowered to a stretcher of a waiting ambulance. CO3 firefighter was then transported to the landing zone for the helicopter for transport to a local hospital.
