IN-DEPTH SURVEY REPORT:
CONTROL TECHNOLOGY FOR SOLIDS MATERIAL HANDLING

GENERAL MOTORS CORPORATION
INLAND DIVISION
VANDALIA OHIO

REPORT NO

MAY 20, 1984

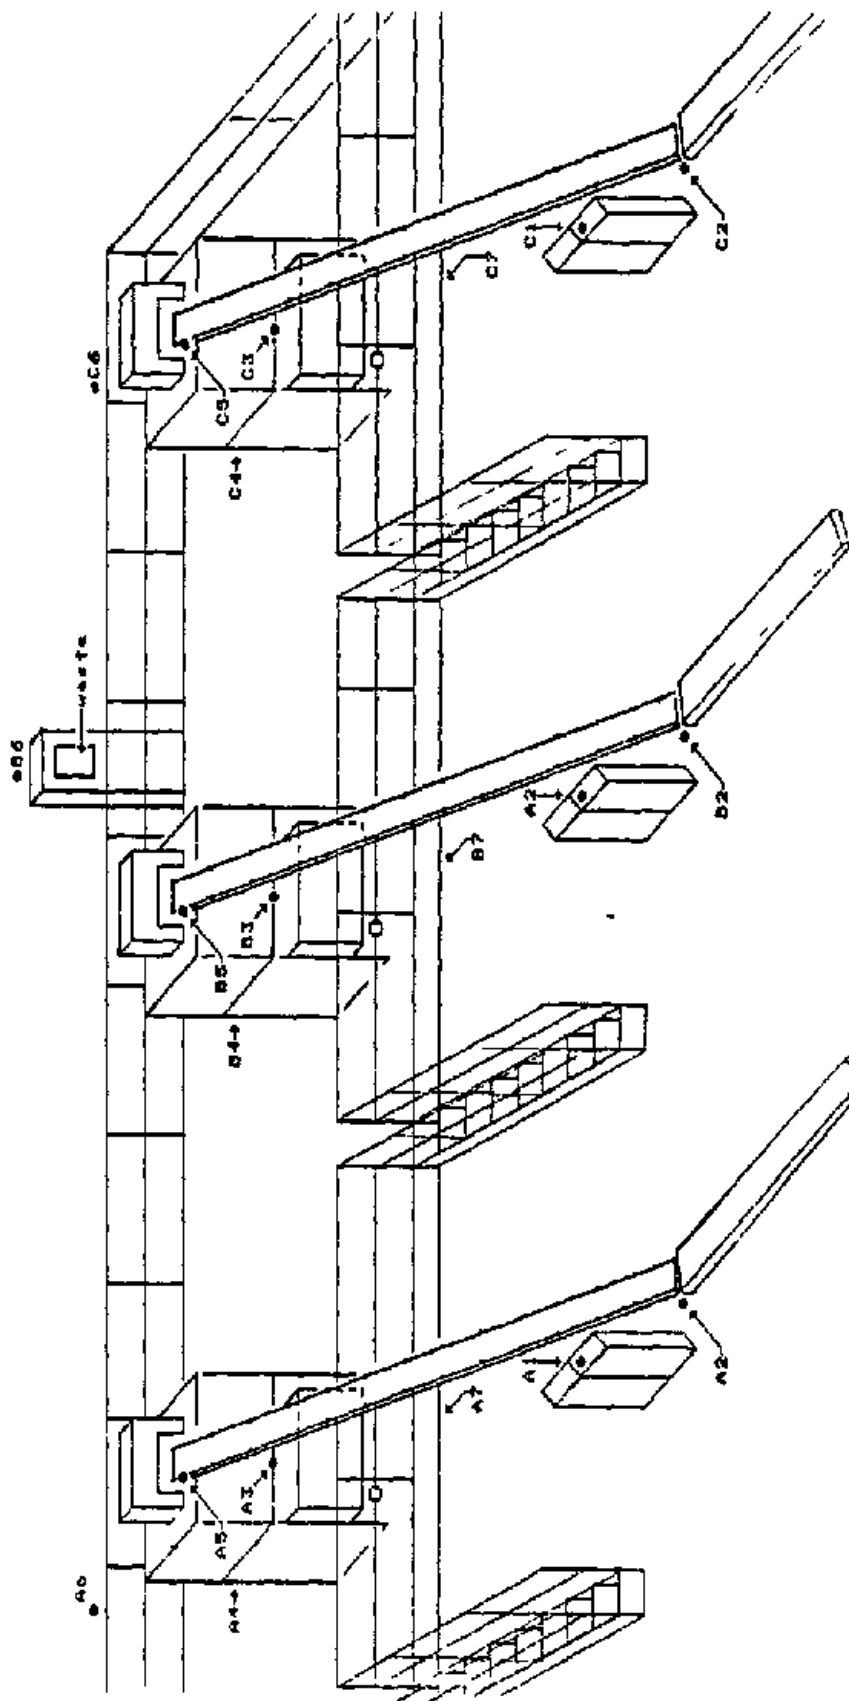
Figure 1. Sketch of debugging area.

At this plant, three bag opening machines are part of an unspecified process to manufacture brake linings. Each bag opening machine is used to feed asbestos into a mixer which is located below the bag opening machine. Figure 1 schematically describes this area. The operator of the bag opening machine is responsible for the following: a) feeding the bags of compressed asbestos into the bag opening machines, b) the operation of the bag opening machines and the associated mixers, and c) moving the output of the mixers to the next processing step.

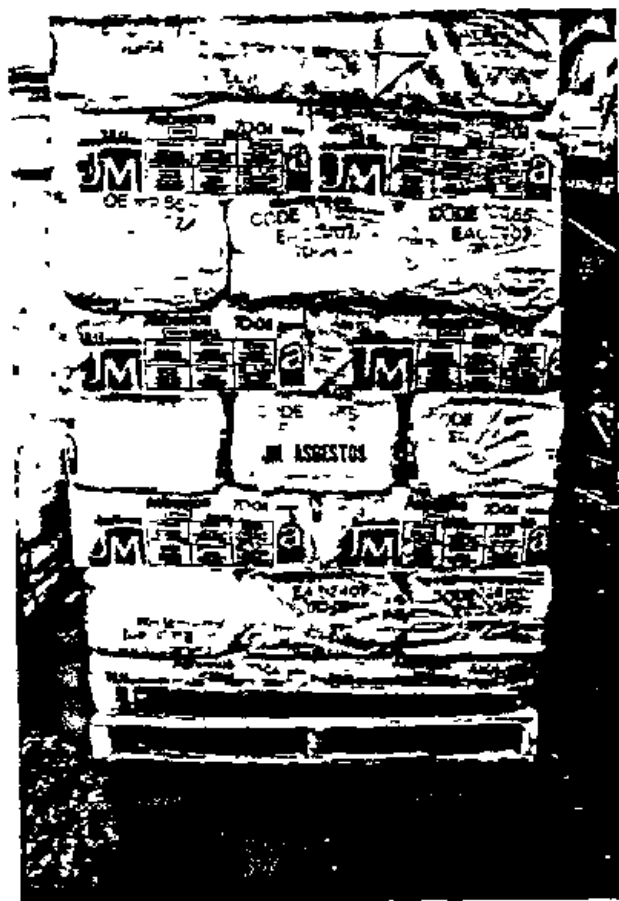
Figure 2. Pallet with cardboard between pallet and bags of asbestos. The cardboard protects the bag from potential tears caused by nail heads in the pallets.

The bags of asbestos, sometimes called asbestos bales, are transported into the compounding room by battery-powered, hand-lift trucks. These bags, which contain 45-kilograms of compressed asbestos, are stacked on wooden pallets. Sometimes cardboard is used to protect the bags from nail heads which protrude from the pallet. Before shipment, these pallets of asbestos bales are shrink-wrapped with plastic as shown in Figure 2. In this area of the plant, the amount of asbestos is restricted to the production needs of no more than one or two days.

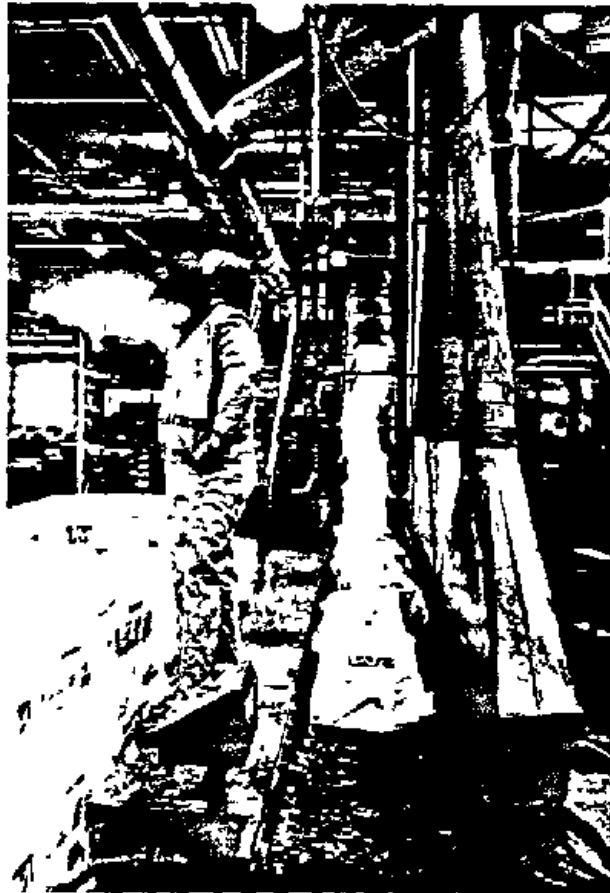
Figure 3. Picture of conveyor which moves the bags of asbestos from the ground floor level to the mezzanine floor where bag slitter is located. Note the respirator use.

To feed the asbestos into the process, the worker picks up the bags of asbestos from the pallet and drops them on the conveyor which carries the bags to the opener. This area is shown in Figure 3. The bags of asbestos fall from the conveyor and into the charge chute of the bag splitter as shown in Figure 4. A saw inside of the bag splitter cuts the bale in half. Spiked rollers separate the bag from the asbestos and discharges the emptied bags into trash hoppers which are shown in Figure 5. The asbestos is discharged through a trap door into a mixer. Between 10 and 15 bags of asbestos are fed into the mixer per batch. These bag opening machines are used every time a batch is mixed. Generally, 6 to 10 batches are mixed per shift.

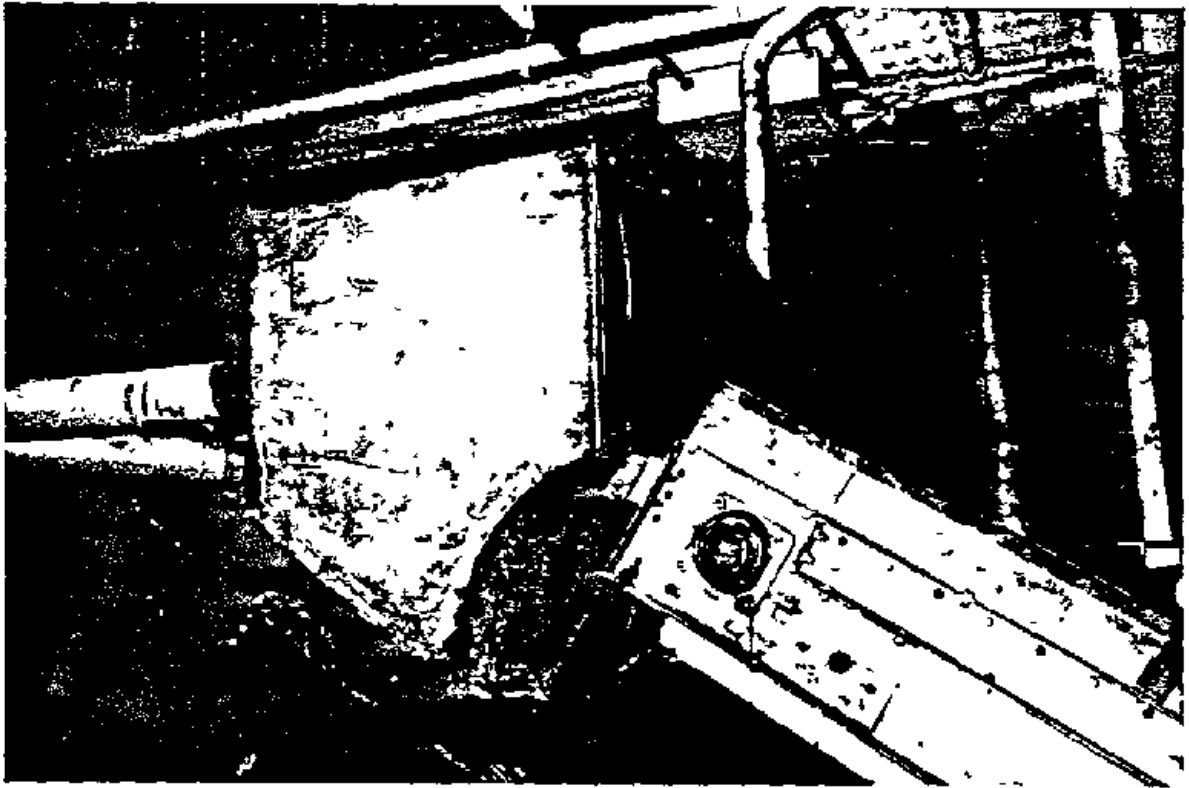
Figure 4. Entry into bag opening machine.

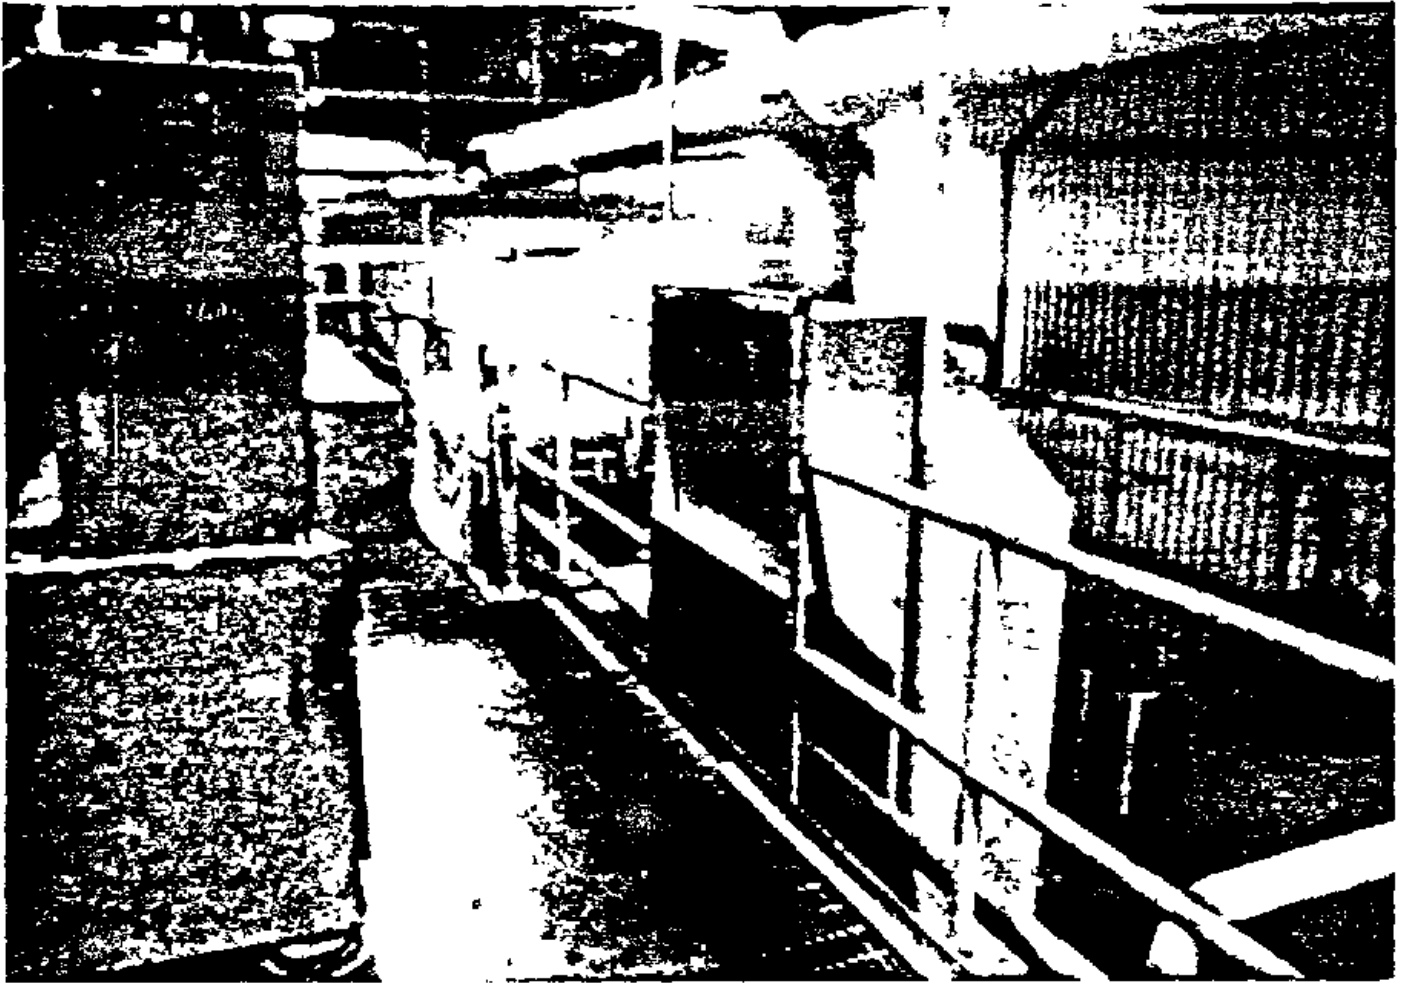
Figure 6. The chute for discarding plastic bags which contain the bag wrappings from the bag opening machine.

2. Use a vacuum line to suck the air out of the plastic bag which is used to line the trash hopper. The vacuum line is part of a centralized vacuum cleaning system for this part of the plant.
3. Pull the hopper out from under the bag opening machine.
4. Tie the bag off and drop it down a special chute into a trash receptacle for hazardous materials pictured in Figure 6.
5. Vacuum the inside of the hopper and the floor around the trash hopper.
6. Line the the hopper with a clean plastic bag.
7. Place the hopper back under the machine.

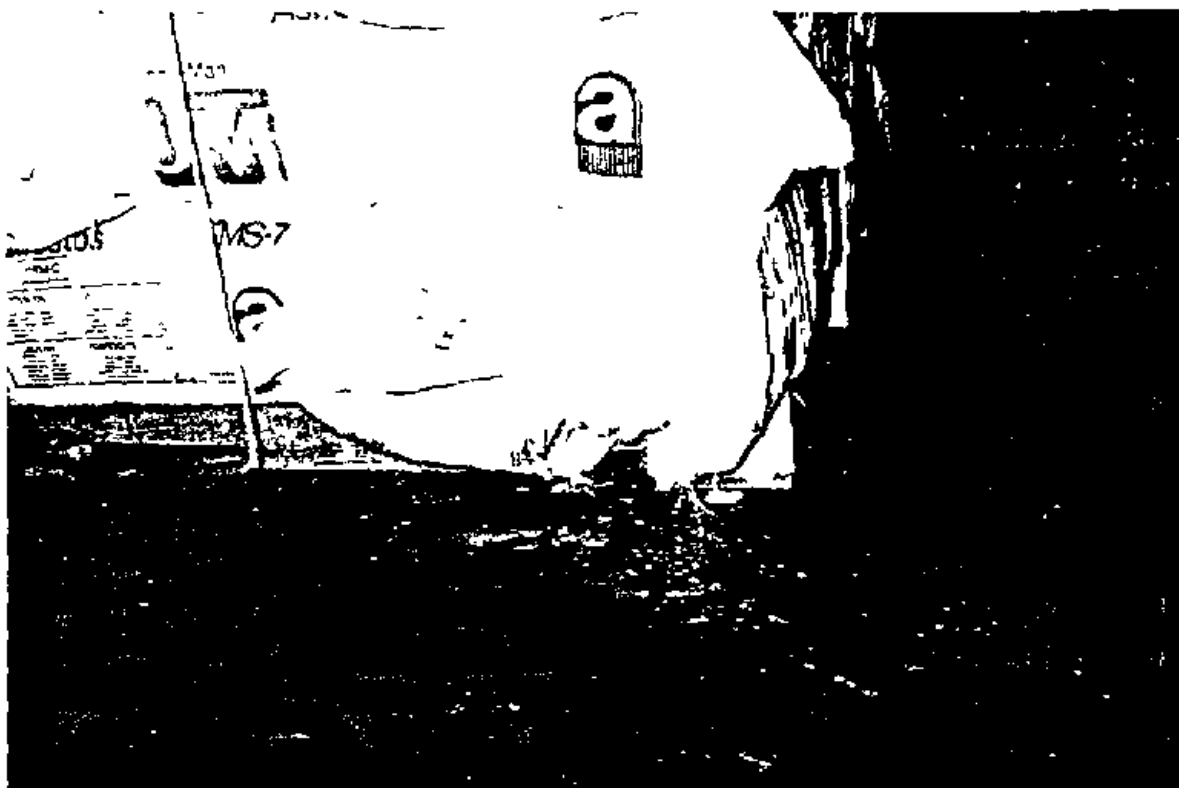
Figure 6. Damaged bag.

1. Holes in the asbestos bags.

This happens for the following reasons: 1. Quality control workers cut holes in these bags to obtain samples. 2. The blades from lift trucks occasionally lance the bags. 3. Nail heads which protrude from the pallet into the asbestos bale can tear the bag. Generally, when the operators observe holes in bags, they promptly patch them and then remove spilled asbestos by vacuuming. (Figures 6, 7)

Work practices play an important role in minimizing asbestos emissions into the workplace. Damaged bags of asbestos are repaired and the spilled asbestos is removed by vacuuming. The procedure for discarding of emptied bag halves (wrappers) was developed to minimize the asbestos exposure while the worker empties the trash hoppers beneath the bag opening machine. The practice of using a vacuum cleaner to suck the air out of the plastic bags used to line the trash hopper is noteworthy. This practice compresses the bags without dispersing asbestos into the air.

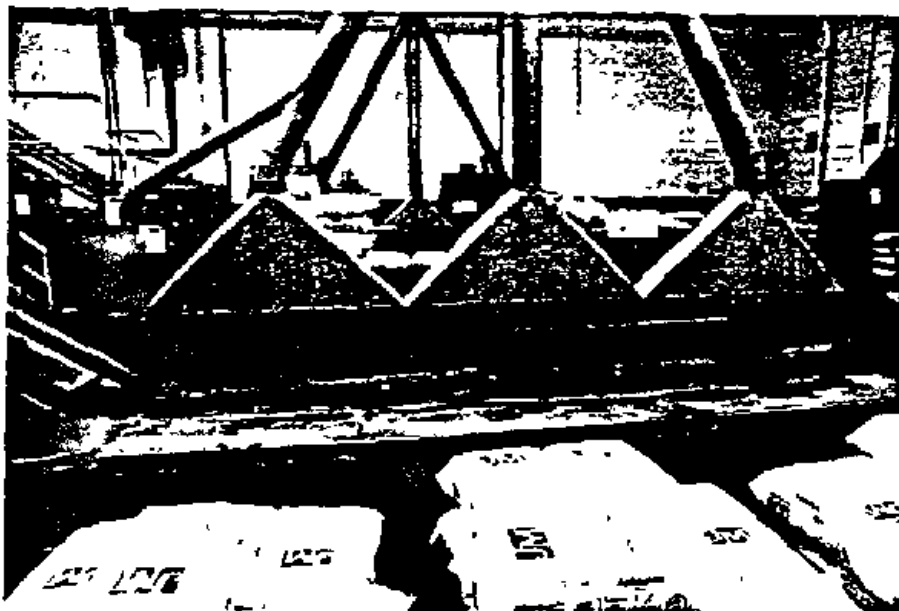
Figure 8. Slot hood next to loading Conveyor. There is a slot hood beneath the transfer point for the loading conveyor and the inclined conveyor which transports the bags to the bag opening machine.

The control of asbestos in the bag opening area of the plant was studied by making ventilation system measurements and measuring the asbestos concentration in the air. The equipment used in this study is listed in Table 2. The ventilation measurements are summarized in Table 3. The slot hood shown in Figure 8 did provide a gentle drift of air toward the slots. However, the air velocities where the workers dropped the bags of asbestos onto the conveyor seemed to be too low to contain whatever asbestos is being emitted into the air. Based upon smoke tube traces, all of the other local exhaust ventilation listed in Table 3 seemed to contain whatever airborne asbestos is being emitted.

Measurement	Quantity
Conveyor hood:	
Slot velocity	1,100-1700 feet per minute (fpm)
Slot Dimensions	about 1"x15' (There are two slots located 4" and 15" above the conveyor)
Air velocities at conveyor edge about 2 feet from slot and 8" above conveyor	0-40 fpm
smoke tube traces at conveyor edge	smoke slowly drifts into slots
Transfer point hood:	
Slot Dimensions	about 1"x26" located beneath transfer point
Slot Velocity	300-1200 fpm
Air velocity at level of conveyor	30-100 fpm
Smoke tube traces	smoke released at conveyor height goes into slot
Entry Hood on Bag Slitter:	
Hood face velocities:	100-300 fpm
smoke tube traces	smoke goes into hood
Trash hopper ventilation on bag slitter	
air velocities in space between trash hopper and side of enclosure	50-100 fpm at top of bins 10-50 fpm between side of trash hoppers and side of enclosure
smoke tube traces	Smoke released along the top of the hoppers just outside of the enclosure flowed into the enclosure

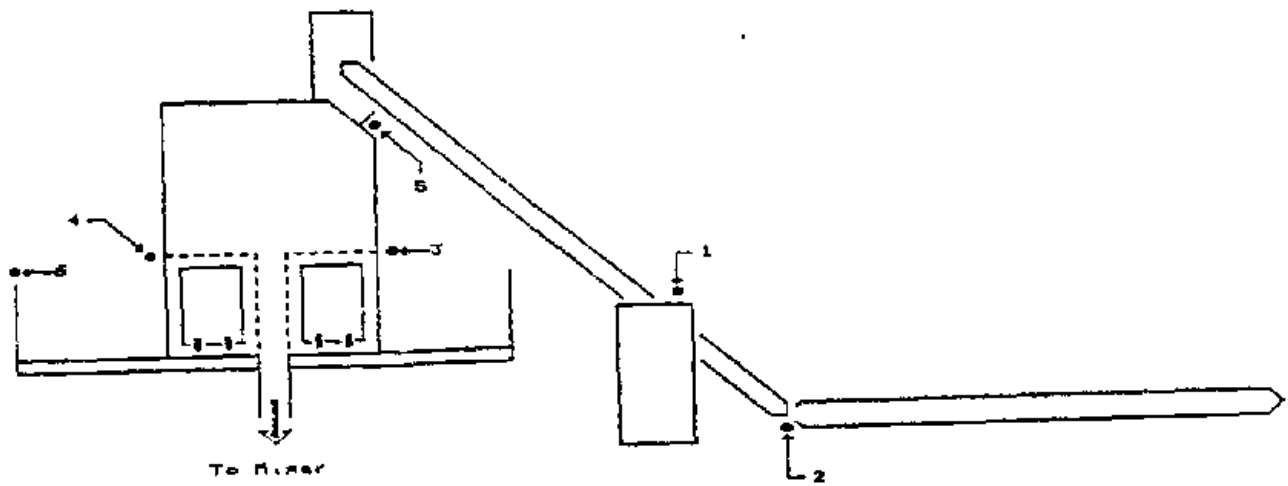
Figure 9. Schematic describing sampling locations.

Location Number	Description
1.	On top of Control Panel. Taken to reflect background contamination
2.	Under conveyor transfer point. This location is under the point where bags of asbestos are transferred from the loading conveyor to the inclined conveyor. Small pieces of asbestos were observed to accumulate on the floor under this transfer point. Possibly, asbestos is emitted into the air here.
3,4	Just above the trash hoppers on the exterior surface of the bag slitting machine. At this location, the emptied bags are being discharged into a trash hopper. If the air flow into the hood is too low, asbestos could be emitted into the air.

5.	Under entry conveyor at inlet to the bag slitting machine. Elevated asbestos concentrations here might reflect leakage from the bag splitter inlet or spillage from the conveyor.

6.	Back railing of the the platform on which the bag splitter is mounted. This sample was taken to estimate background asbestos concentrations in the area of the bag splitter.

7.	Underneath bag splitter on platform for the mixer. Asbestos concentrations at this location might be elevated because people walk on the grated floor above the mixer.

Sampling results are listed in the attached appendix. Generally, the area samples collected during the off conditions were just at or below the detection limit of about 0.01 fibers/mL. Table 5 summarizes the worker's asbestos exposures and the sampling results obtained from the samples which were collected during "on" conditions. The "on" samples collected at locations 3 and 5 and on the worker were consistently above background. The results from these locations suggest that there is some asbestos generated when the conveyor belt wraps around a roller at the inlet to the bag slitting machine. In addition, the airborne asbestos generated within the bag disposal bin is a possible source of emissions into the workplace. Because the ventilation for the disposal bin appears to be adequate, the conveyor belt appears to be the source of the increased asbestos concentrations at locations 3 and 5.
